## The Accuracy of Photogrammetry vs. Hands-on Measurement Techniques used in Accident Reconstruction

2010-01-0065

Bryan Randles  
Biomechanical Research & Testing

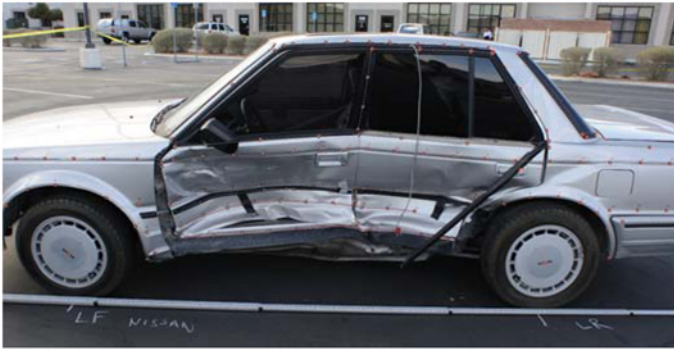
**Figure 1. Maxima driver's side damage and measurement points**

a baseline model, obtained using total station points from the undamaged areas of the vehicle, and matched in a CAD program. Measurements were taken from the predefined damage points along an axis perpendicular to the station line in the CAD program. The result was a 2-D representation of the vehicle measurement in the vehicle X-Y plane [25,26] at the prescribed heights. This method of vehicle measurements conform with those set forth by the Society of Engineers [5] and those used in vehicle damage analysis [4,8]. Figures 1,2,3,4 show an example from one of the PhotoModeler projects for the Maxima, Thunderbird, front of the Accent and rear of the Accent, respectively. Figures 3 and 4 show the prescribed station line that was used in the analysis

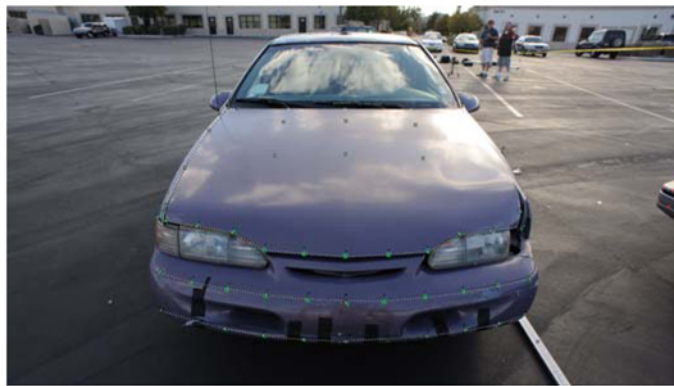
**Figure 2. Thunderbird front damage and measurement points**

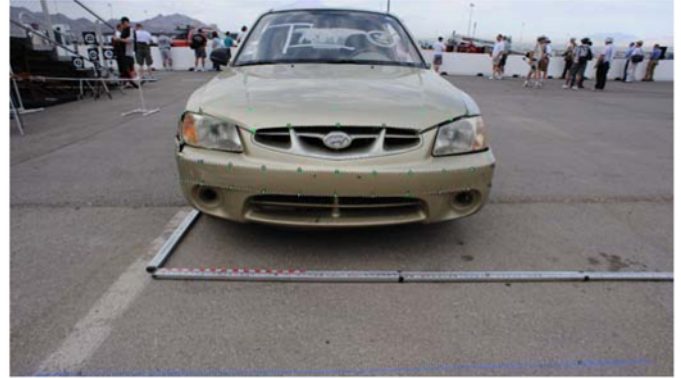
**Figure 3. Accent front damage, measurement points and station line**

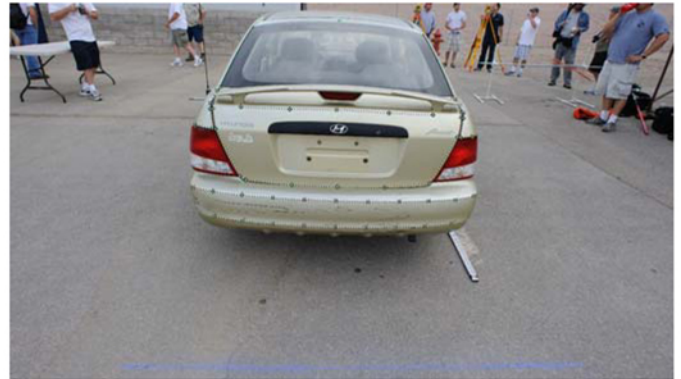
**Figure 4. Accent rear damage, measurement points and station line**

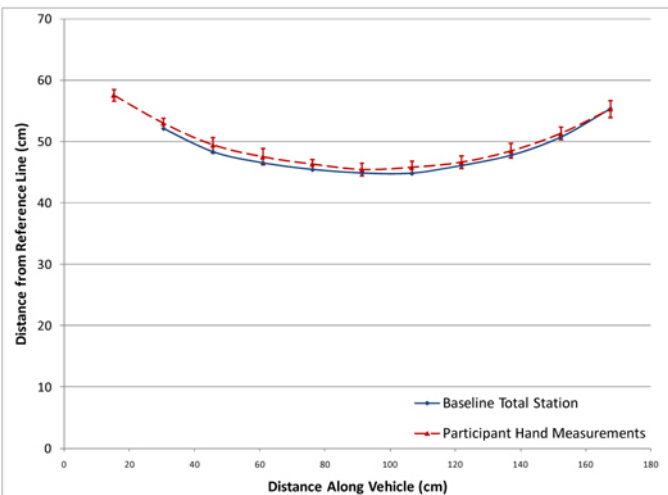
Figures 5 and 6 show the results for measurement points on the rear of the Hyundai Accent from hands-on measurement and photogrammetric analysis, respectively. The error bars denote the standard deviation of the measurements. The values on the Y-axis represent the measurement distance from the prescribed station line and the values on the X-axis represent the distance between the measurements along the station line. Figure 7 shows the mean values for the measurement points obtained from both methods, as compared to the baseline total station measurements. Any gaps in the data in the following figures represent points that were not measured by a given method because they were not visible.

**Figure 5. Accent rear bumper cover participant measurement mean and standard deviation comparison to baseline total station**

Qualitative examination of both participant hand measurements and PhotoModeler measurement data showed a strong agreement with the baseline total station measurements, as depicted in Figures 5,6,7,8,9,10,11,12. Based on these measurement sets, it appears that both methods are appropriate for accident reconstruction and damage analysis.

The rear of the Accent (Figures 5,6,7) showed the best overall agreement in measurement profiles for both the participants and PhotoModeler measurements, with the standard deviations for both essentially encompassing the baseline measurements. The largest difference between the mean participant measurement and the baseline total station measurement was 3.2 cm, while the largest difference between the mean PhotoModeler measurement and the corresponding baseline total station measurement was 0.9 cm, indicating a greater accuracy for the PhotoModeler method. The standard deviation for the PhotoModeler measurements was also considerably lower than that for the participants (0.2 to 1.1 cm)

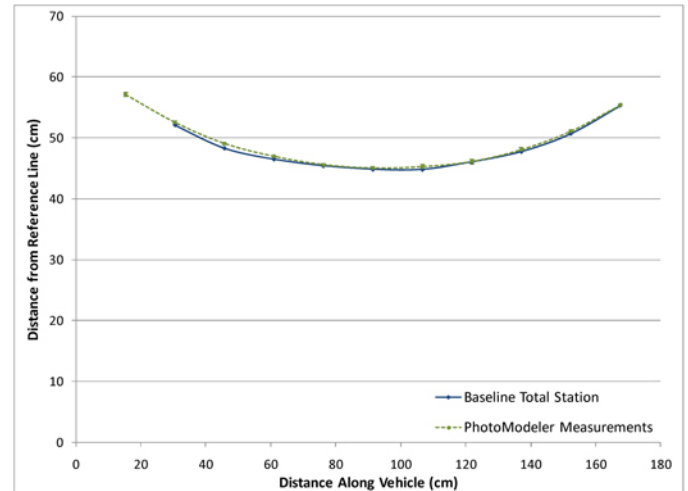
**Figure 6. Accent rear bumper cover PhotoModeler mean and standard deviation measurement comparison to baseline total station**

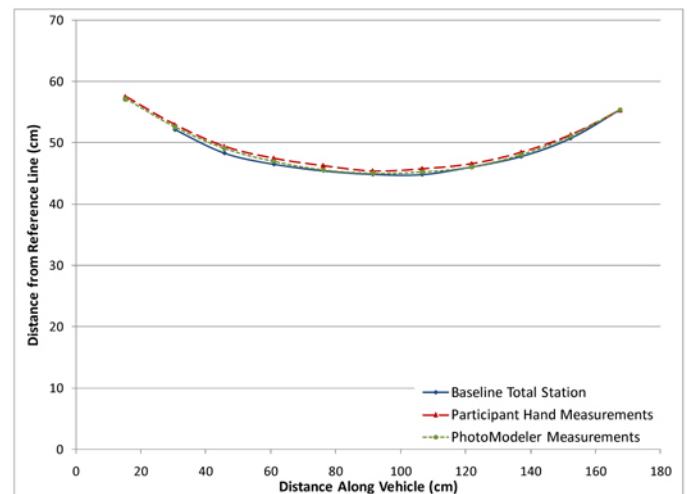
**Figure 7. Accent rear bumper cover measurement method comparison**

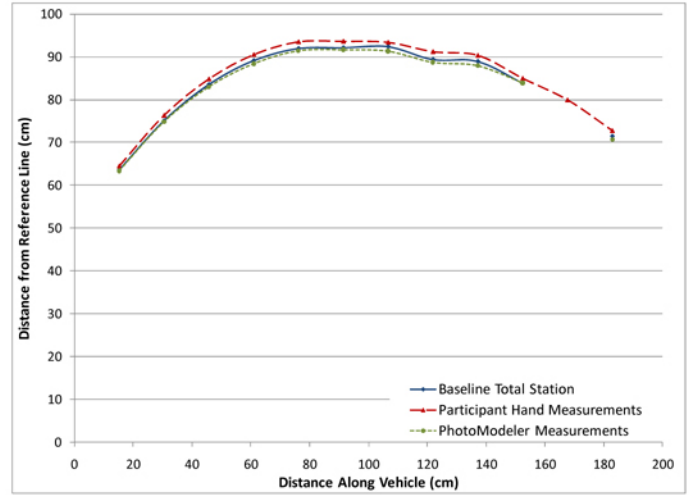
**Figure 10. Maxima side door measurement method comparison**

The driver side of the Maxima (Figures 8,9,10) showed the worst overall agreement in the measurement profiles and relative error for both the participants and PhotoModeler measurements. Both measurement methods again showed relatively good agreement with the baseline total station, even for this worst case, with the PhotoModeler analysis again appearing slightly more accurate than the participant measurement technique.

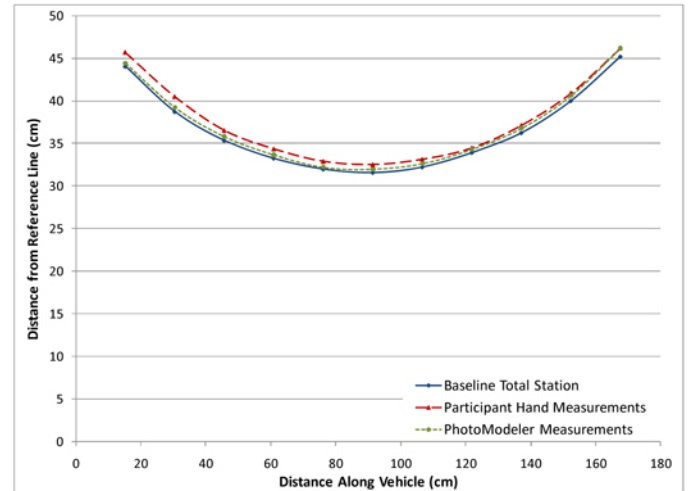
Figures 11 and 12 contain comparisons for the lower edge of the front bumper of the Thunderbird and the upper edge of the right side front bumper cover of the Accent, respectively.

**Figure 11. Thunderbird front bumper cover measurement method comparison**

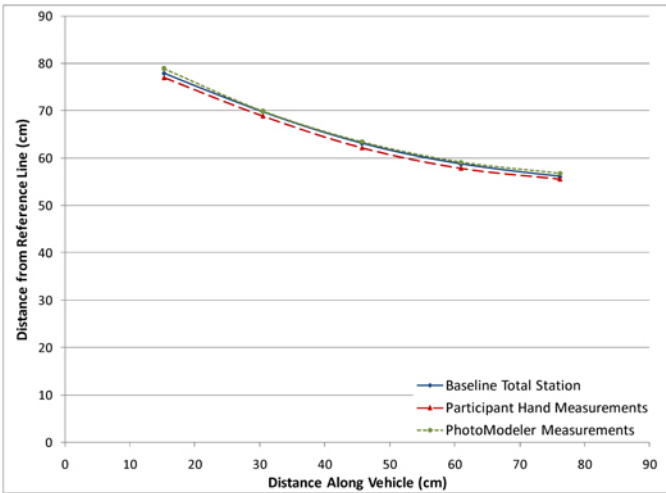
**Figure 12. Accent front bumper cover measurement method comparison**
